# Medium T – 34/85

## ABSTRACT

The present work decomposes all of the prevailing issues found in the tracks of The Tank Museum's T-34/85 in terms of wear and corrosion. These have been taken in count for the creation of their corresponding design engineering solutions.

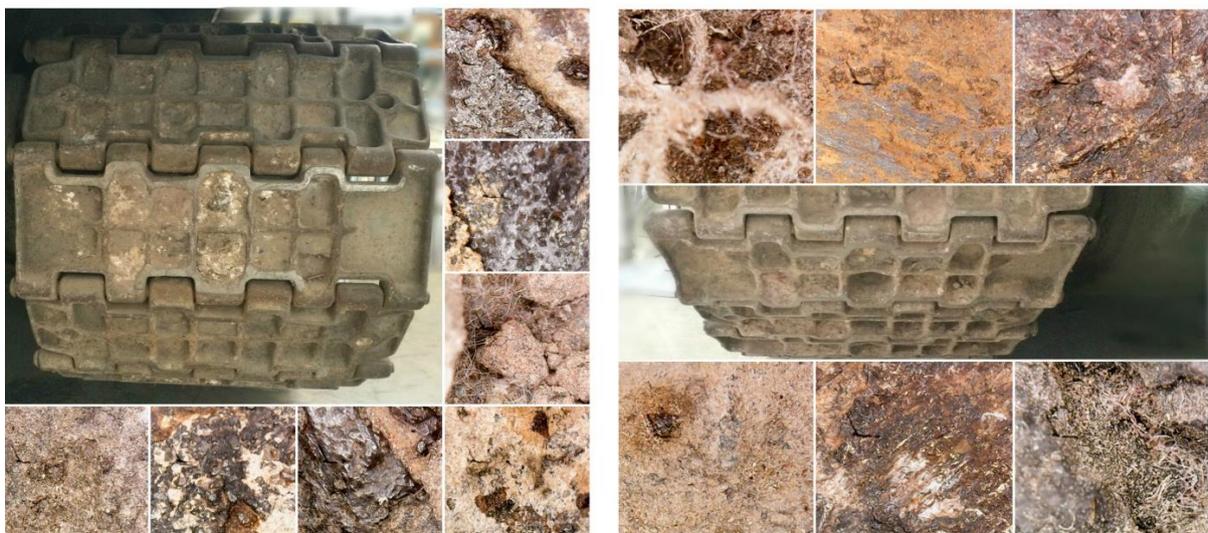
Fig. 1 Left track w/ debris + close up to its underside. Fig. 2 Right track and its underside.

The tracks have been designed wide so the ground pressure can be reduced. The waffle-pattern found in the T-34/85's tracks includes a raised pattern on the outside of every track link to maximize the traction. Each track consists of 74 steel track links. Every other track link has a guide horn which serves to mesh with the sprocket wheel and hold the track in position. The track links are hinged to one another by 148 pins. The pins are prevented from falling out by keepers. Each track has holes for fastening additional spuds, and they're fixed by two bolts to the track.[2] Although it is known that castings of non-magnetic austenitic steel were used for the manufacture of tracks, there is missing information, in terms of its percentage composition. As well as for the case-hardened track pins. (2<sup>nd</sup> T.T.O, 1950: 90, 98) There currently is considerable wear on the underside of the plates. The elevated underside waffle-pattern shows

a lot of indentations and wear. Corrosion is present on the guide horns contact areas with sprockets, and road-wheels, as seen in Fig. 5. On the pin contact area with the track plate, rust, and mostly, wear can be found.

The tracks were casted from a variety of carbon steel plates containing different amounts of the components found in Table blank. The track plates were then austenised for a few hours, and finally quenched. After that, they were casted into shape- keeping its austenitic composition. The hardness used by the Russians is said to be higher than the one used by the Americans. It aimed to obtain maximum resistance to penetration by sacrificing structural stability on impact. [3] Yet, as seen in Figures 1 and 2, there's several scratches present on the tracks' surface.

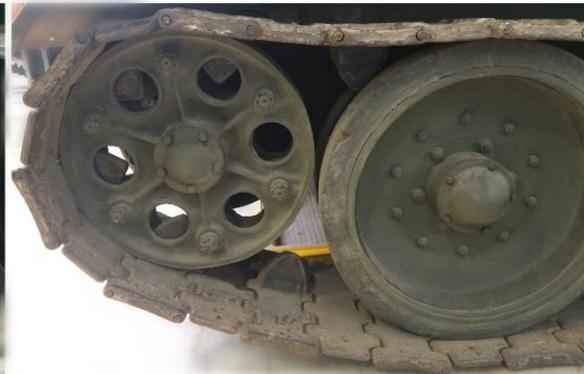
**Fig. 4 Left-loose track + driven sprocket-wheel.**

As the sprocket wheels rotate they drive the tracks by means of the rollers which bear against the guide horns. The wheel is fixed by a ring, which is screwed by four studs to the end of the final drive shaft. The securing ring is covered by an armored cap. The hub of the wheel has a flange. In this model the rims of the wheels are hardened. The discs of the wheel are bolted to the flange. The discs have six large exit-holes and six seatings for the shafts of the rollers. To *prolong* the life of the rims, steel tyres are fitted. The shafts are housed between the discs and carry bronze bushes upon which the rollers rotate. Carbon steel was used for both the sprocket wheels and its rollers. The inside of the sprockets were casted, and the rollers hardened. [2] Wear is present on the contact areas of the exit holes, where snow and mud has gone through. There are cracks on contact area between the sprocket wheels, specially its rims, and tracks. Since the road-wheels are rubberized, their plates and rims aren't greatly affected. This sacrifice is clearly seen in the uniform wear around the contact area with the casted-road wheels, and around the contact area with the track plates.

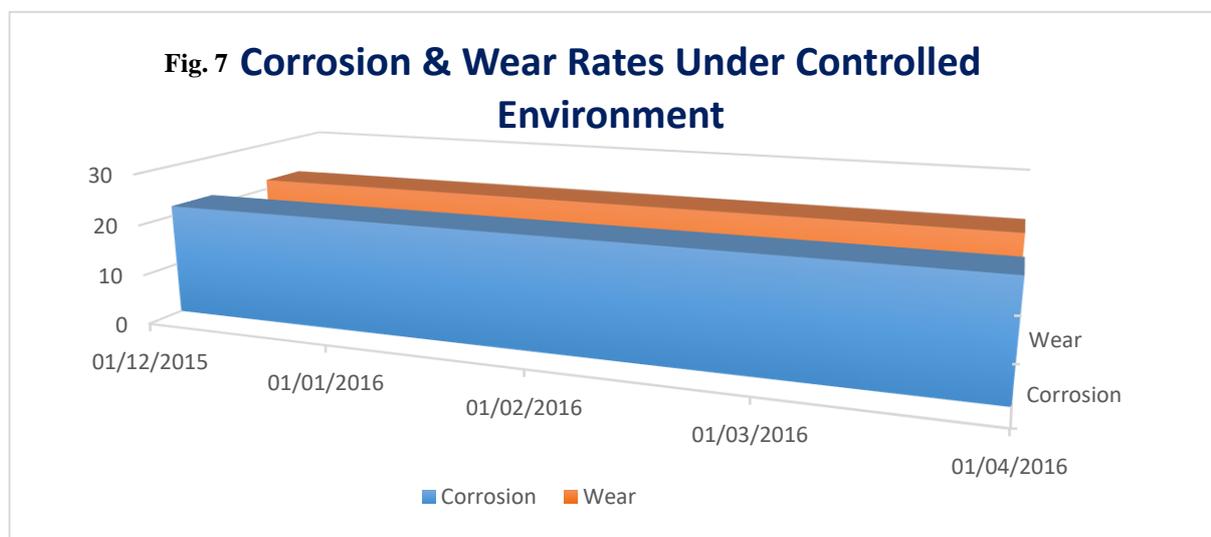
**Fig. 7 Corrosion & Wear Rates Under Controlled Environment**

In terms of wear there seems to be a tribochemical wear, which is capable of increasing with exposure to increase of temperature, but since the T-34/85 is stationary within a controlled environment it isn't an issue as shown in Figure 7. Scanning Electron Microscope method could've been used, so reliable data could be integrated into the corresponding formulas. A more accurate value for the time-dependent concentration of ionic compound in controlled environment found using duty cycle concept could've been obtained. For more details, refer to Appendix.

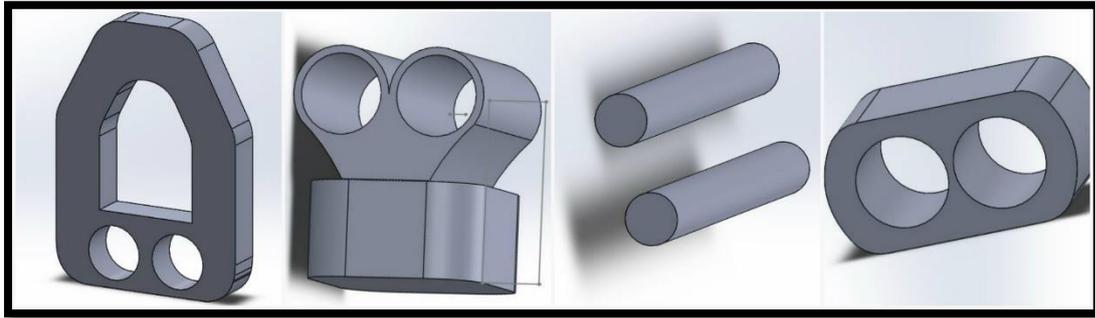
**Fig. 10 Re-designed components. From left to right: Horn, Track Plate/ Shoe & Link, Pins, Keepers.**

Each track consists of 74 couples of Mangalloy track links. In between each couple, the Tungsten Carbide 'framed' horns will be hinged, which serve to mesh with the sprocket gears and hold the track in position. There are 148 Silicon Nitride pins to hinge all the components, and 74 keepers of the same material, to prevent the securing pins from falling out. The two double sprocket-gears will remain at rear. These Magnesium Alloys gears proceed to be screwed by four studs to the end of the final drive shaft. Each driver sprocket has six large gaps between the six seatings for the shafts of the Tungsten rollers serving as exit holes. The shafts are then housed between the gear-plates upon which the rollers rotate. Finally, the new double-tyre road-wheels' Polybutadiene Rubber will be pressed and welded on the plates of the current 'bogie wheels.'

Component	Material	Process
Track links	Mangalloy	Cast austenitic, quench annealed and work-hardened
Track horns	WC	Continuous casting + Electroless Nickle w/ WS2
Track plates 'shoes'	Al <sub>2</sub> O <sub>3</sub>	Casted + (optional) Anodizing w/ WS2
Keepers	Si <sub>3</sub> N <sub>4</sub>	Hot pressed
Pins	Si <sub>3</sub> N <sub>4</sub>	-
Sprocket plates (optional)	AZ91E	Die castings
Sprocket rollers (optional)	WC	-
Road-wheels (optional)	BR	Continuous Processing Polymerisation

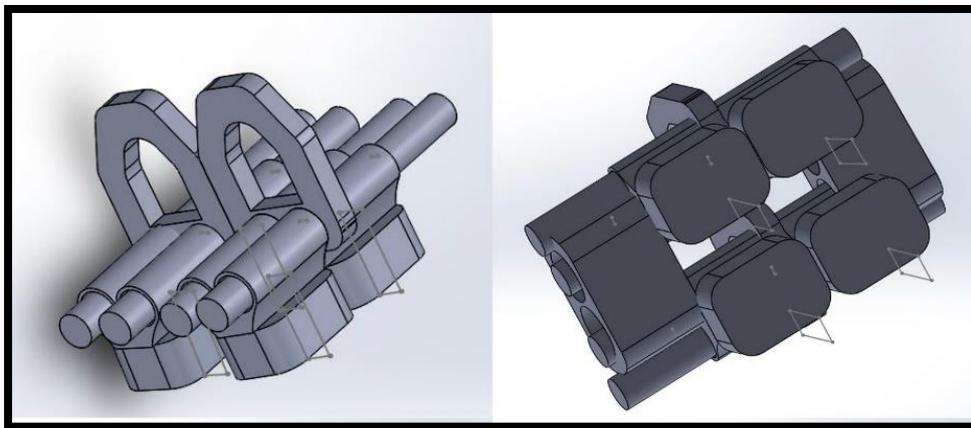
**Fig. 11 A couple of double-track sets assembled in Solidworks.**

Each of the T-34/85's new tracks will comprise 72-times the assembly done in Solidworks.
